The Bright Side of Termite Damage

In 2006, the Monocacy National Battlefield hired the Historic Preservation Training Center to paint the exterior of the Best House. Extensive termite damage resulted in the need to remove many layers of surface finishes in order to address the structural deficiencies. But the removal of layers of plaster and drywall revealed previously unknown details about what is considered to have been the kitchen outbuilding.

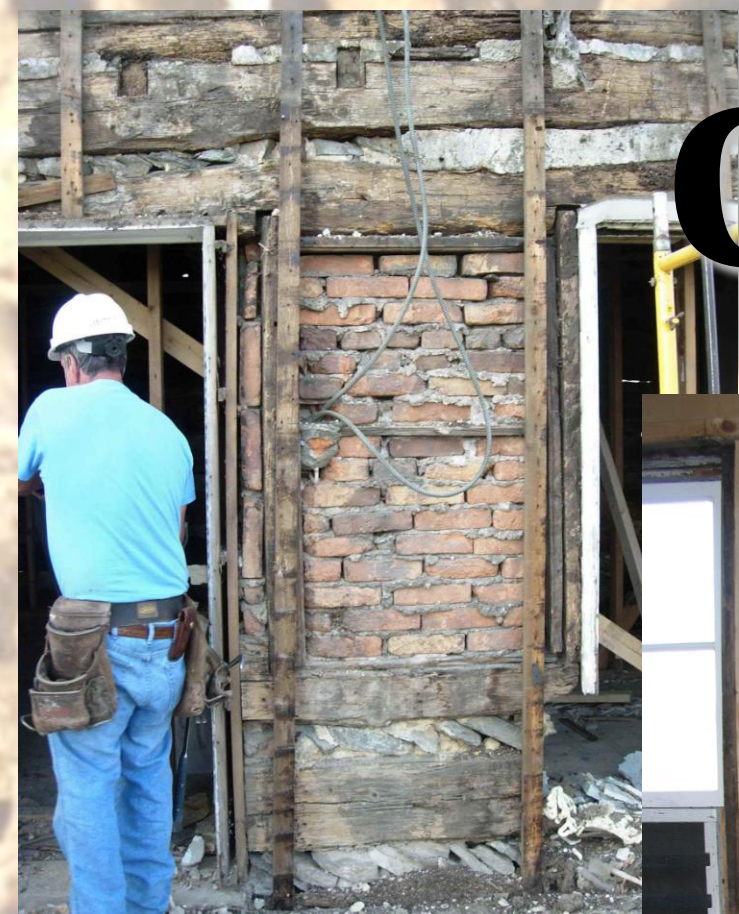
3. Interior and exterior views of the newly discovered window opening. The yellow ochre color was seen on no other features in the room.

2. The room was whitewashed prior to plastering and apparently did serve as a kitchen as indicated by the dark staining on the ceiling.
3. An undetected window was uncovered. The window had been bricked in, apparently in an effort to provide symmetry to the window pattern on the north elevation exterior. This window is directly across from an early-period window on the south elevation.

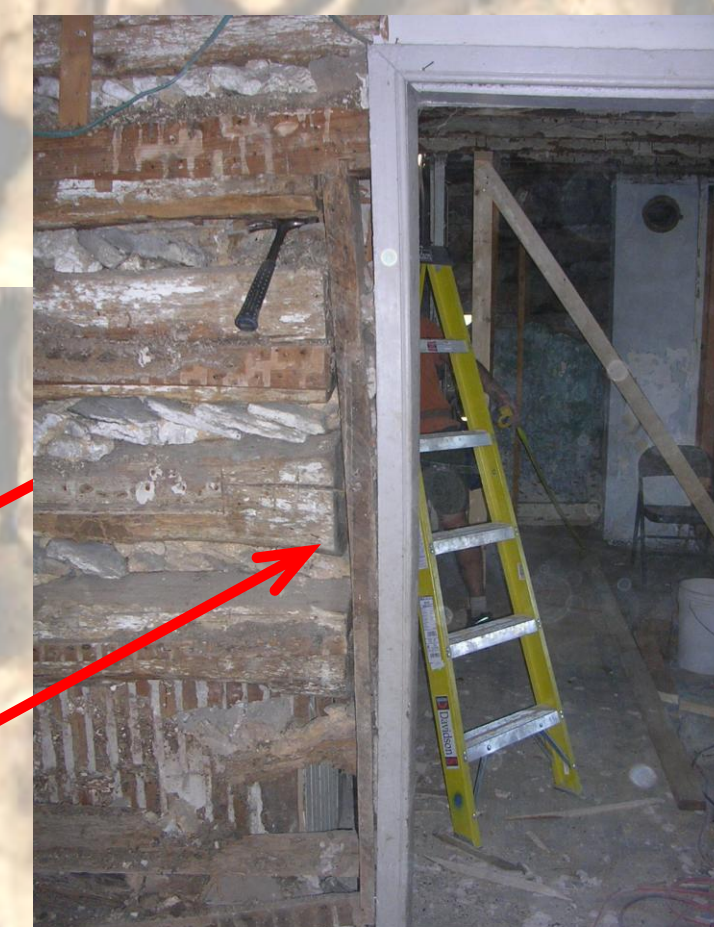
4. Remnants of the early door frame are extant

4. An early doorframe was discovered, proving that the doorway had been in that location through much of the structure's history.
5. Though the room had been painted many shades of blue over the years, this brilliant blue appears to be the earliest paint color on the plaster walls.

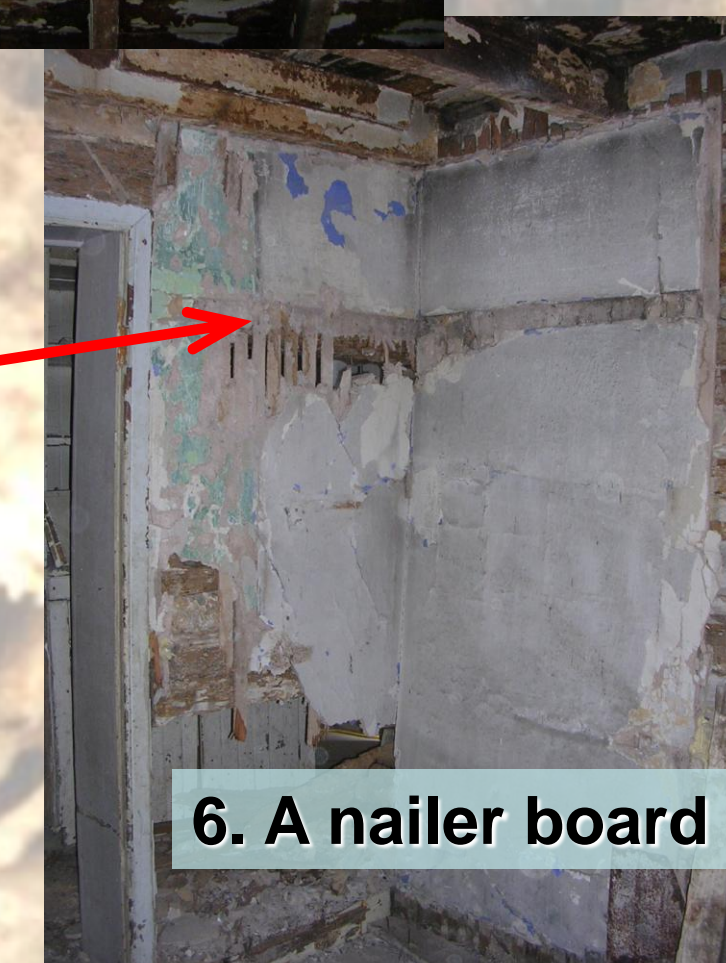
6. A nailer board or pegboard

6. A nailer board or peg board had been installed in the southeast corner. The board was used as a nailer when a cupboard was built into this corner. This board is still attached to the back of the cupboard.
